Paul S. McCreary, PE
Consulting Engineer
22 Maxwell Street - Albany, NY 12208
518-248-0712
psmpece@gmail.com

Subject: Visual Building Inspection
Former LVPA Firehouse
523 US Route 20, New Lebanon NY 12125
Tax ID: 19.2-1-56

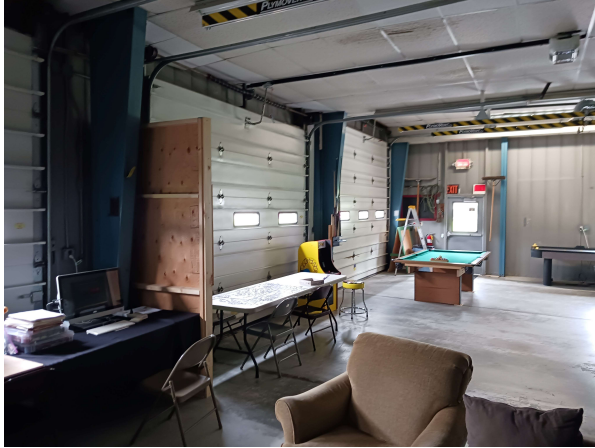
Photo 7: Existing Vehicle Bay (Currently space used for the Community Center)

- Given the intended use change of the building, at some point, the multiple overhead door openings would need to be converted to walls. This would be for the sake of saving energy costs. Additionally, exterior doors and windows should be replaced for the very same reason. This would not necessarily be an immediate item to perform, but the sooner the better for energy cost savings.

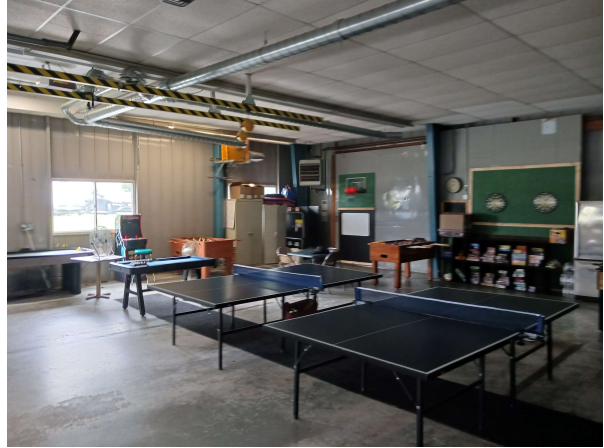
Photo 8: Existing Vehicle Bay (Currently used for Community Center)

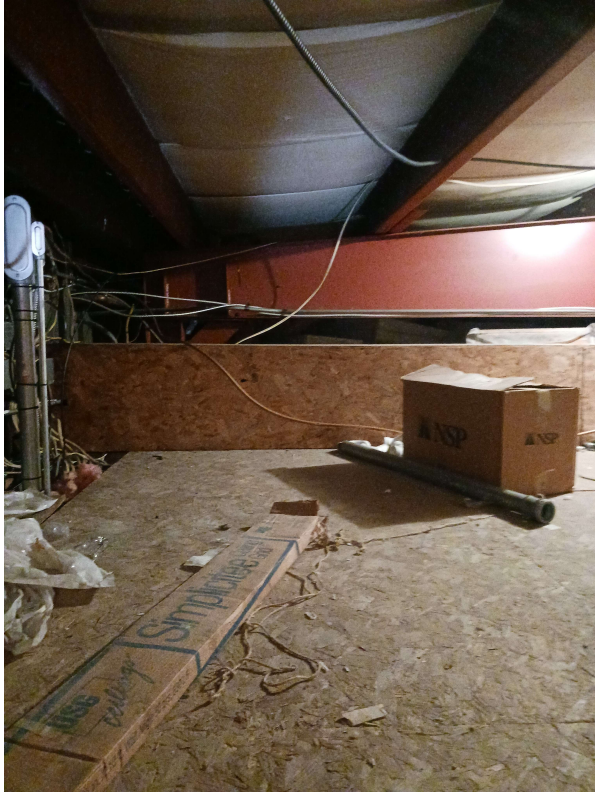
- Structurally, the building is in good condition,
- The building has some normal wear – nothing out of the ordinary.
- Observations while in the attic space (limited viewability) showed no signs of leakage. There were also no ceiling stains indicating same,
- The location of the well (water supply) for the building is located in the slab of what is now being used as the “Free Store”,
- The Firefighting vehicle bay has a trough drain that leads to a seepage pit under that same slab,
- The septic tank for the building is between the building and Shaker Road. The subsurface disposal system is located in the rear parking area, and;
- There are 9”x9” tiles in the front room. There is the possibility that the tiles could have

Photo 12: Attic Space

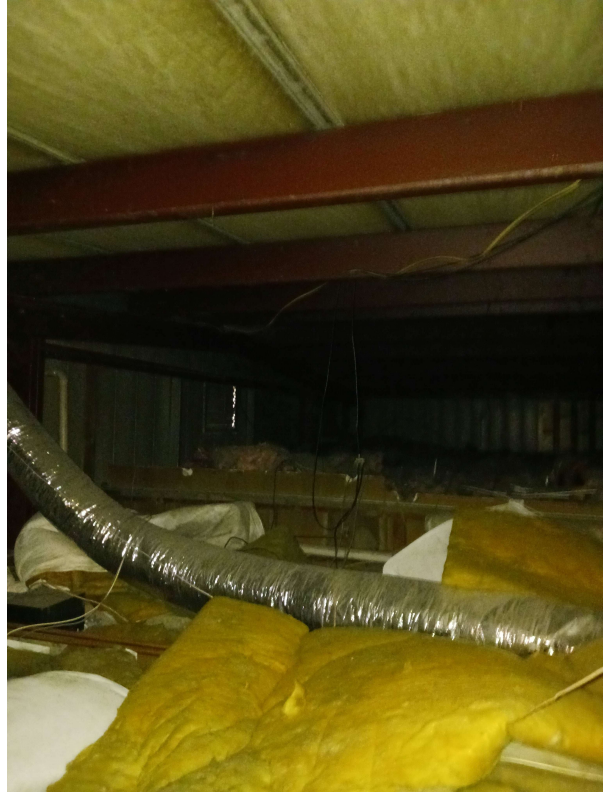
Photo 13: Attic Space

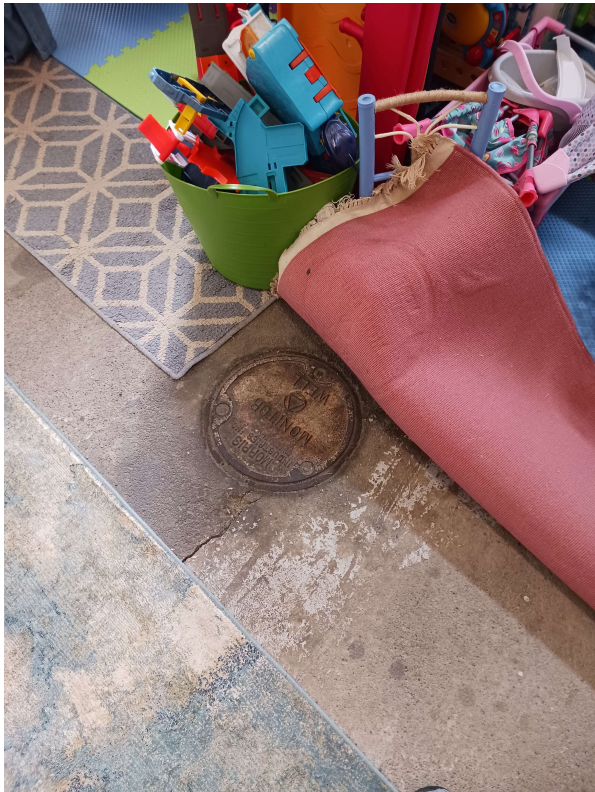
Photo 14: Well (in Paramedic vehicle bay)

- Given the proximity of the well, septic and interior drains, it is recommended that the water be tested for contaminants. A full spectrum test of the water should be performed, i.e.; testing as if it were a public water supply well.

- Given the possibility of asbestos containing materials, it is recommended that an environmental assessment for hazardous materials be performed.
- Given the intended use of the building (a Community Center with a kitchen) the building should be served by a Public Water Supply (PWS) Well. Specifically, the PWS well would be classified as a Transient, Non-Community, Water Supply well. This would only apply if the existing kitchen were to be used for food preparation of any kind. At the very least, the Town should get a determination from the Columbia County Department of Health (Environmental Health Section) to see what, if anything, can be done to attain this type of water supply well. While there are waivers that can be granted for ownership distances and separation, that organization is the keeper of that goodness and can assist the Town. At the very least, strong filtration and disinfection would be required. Also note, relocation of portions of the On-Site Wastewater Treatment System may be needed.

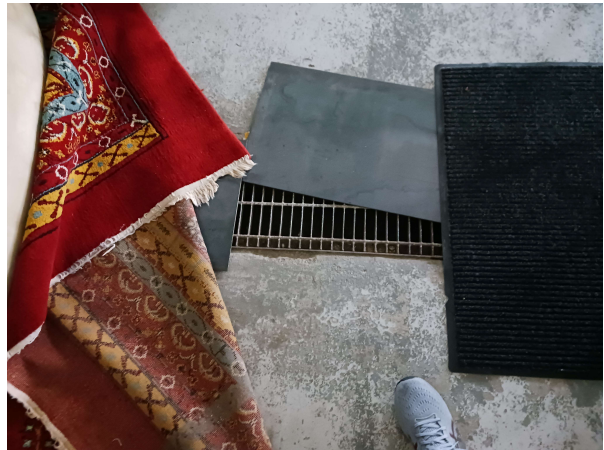
Photo 15: Floor Drain in Firefighting Vehicle Bay

- The trough drain in the large vehicle bay should be filled in (concrete).
