Paul S. McCreary, PE
Consulting Engineer
22 Maxwell Street - Albany, NY 12208
518-248-0712
psmpece@gmail.com

Subject: Visual Building Inspection
Former LVPA Firehouse
523 US Route 20, New Lebanon NY 12125
Tax ID: 19.2-1-56

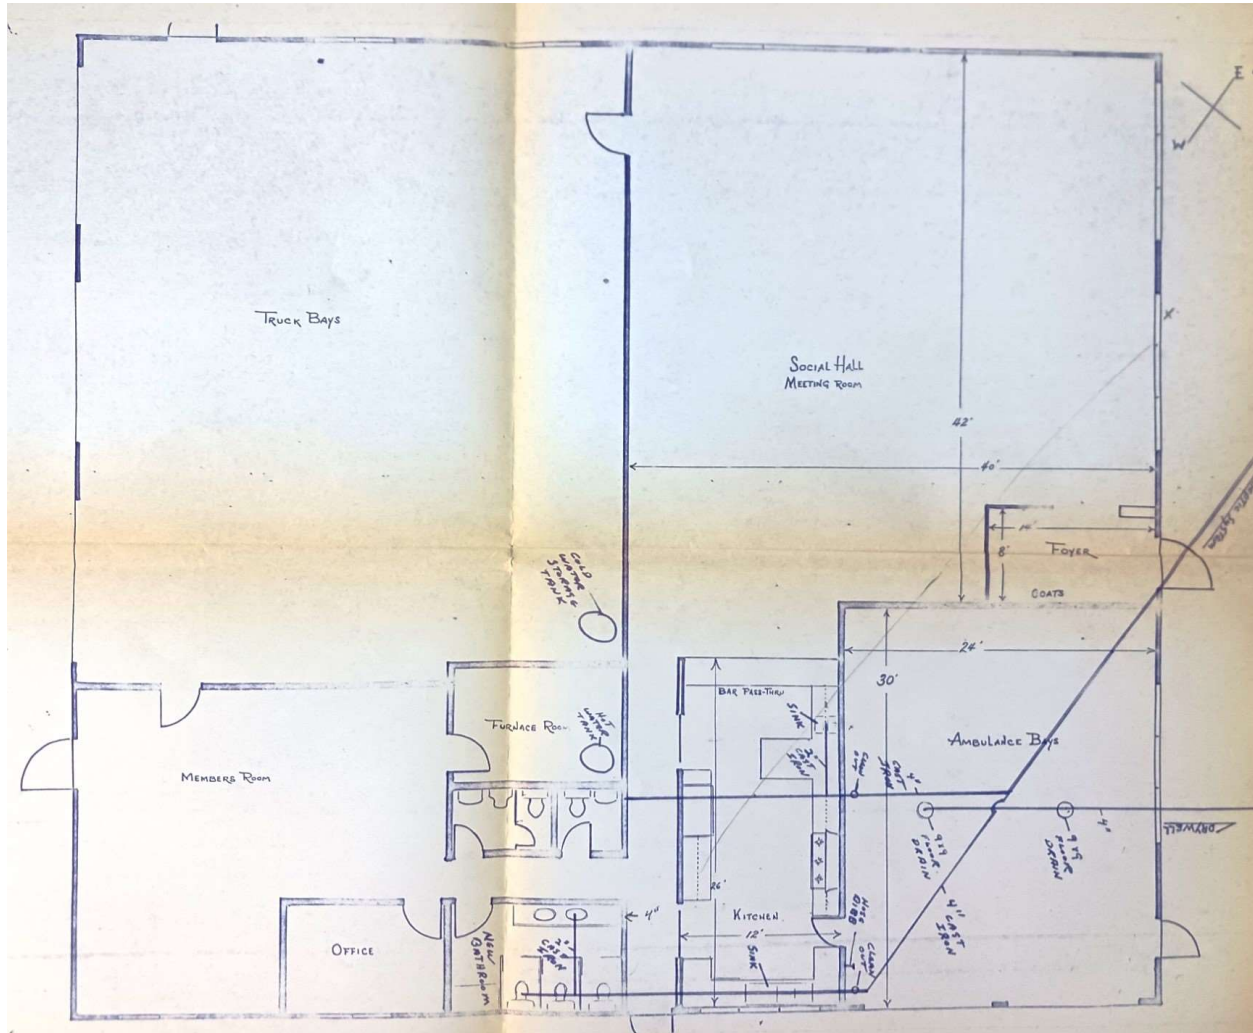
For everyone's knowledge, the building has the following features/rooms. A large vehicle bay with three (3) overhead doors (this was the area that housed the Firefighting Vehicles), a front room that was the office and small meeting space for the LVPA, a full/large commercial kitchen; a large meeting room; bathrooms; storage spaces/areas; and an EMT Vehicle bay with two (2) overhead doors. On the following page is a photograph taken of the floor plan included in the building file given me by the LVPA.
